373 George Road

Home Inspection Report

Inspection Date: 2026-02-22

Address: 373 George Road
Birmingham
United Kingdom
B23 7RY

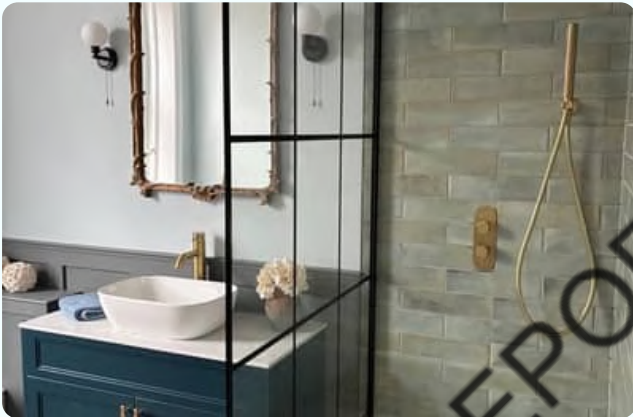
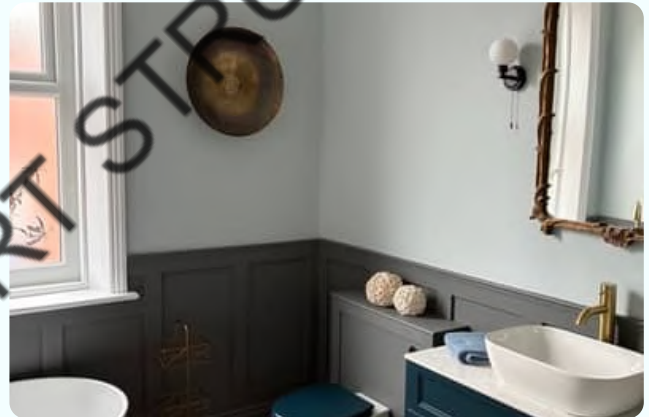
There are visible damp patches on the corner wall near the ceiling, showing signs of moisture ingress or condensation.

The damp patches are likely caused by condensation due to inadequate ventilation or minor water ingress from the external wall or roof junction.

Visible damp patches on wall

Investigate ventilation adequacy and improve if necessary. Treat affected areas with appropriate damp-proofing and redecorate. Consider specialist damp survey if damp persists.

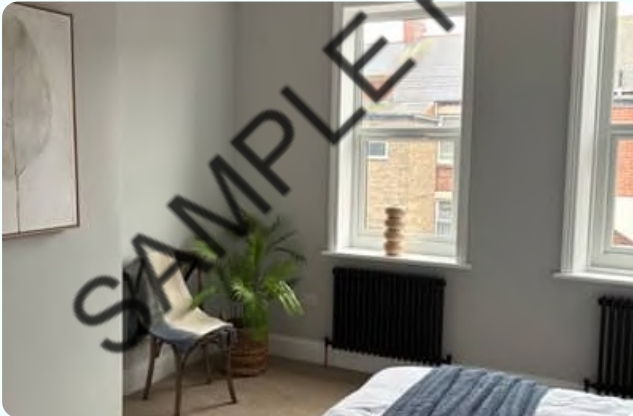
The carpet shows signs of typical wear consistent with normal use. There are no visible stains, tears, or significant damage.

Typical carpet wear

Routine cleaning and periodic replacement as part of normal maintenance.

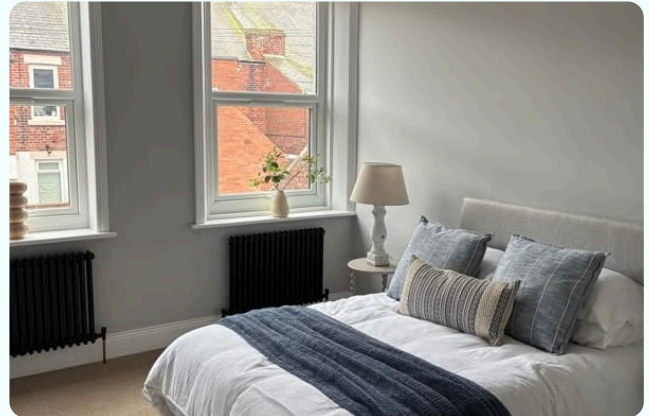
Typical carpet wear

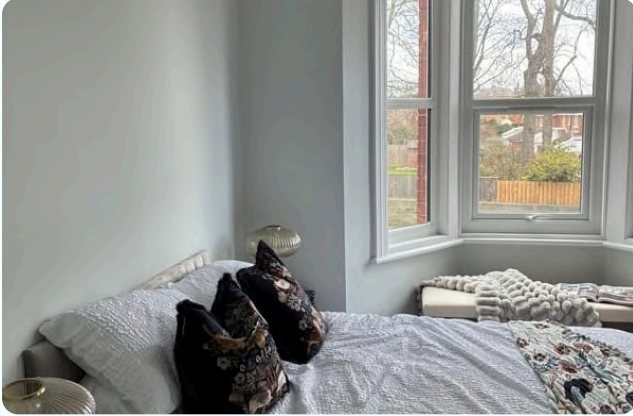
There are minor paint blemishes visible on the walls, particularly near the corners and edges. These appear to be superficial and typical of normal wear and tear.

Minor paint blemishes on walls

Repaint affected areas as part of routine maintenance to improve aesthetics.

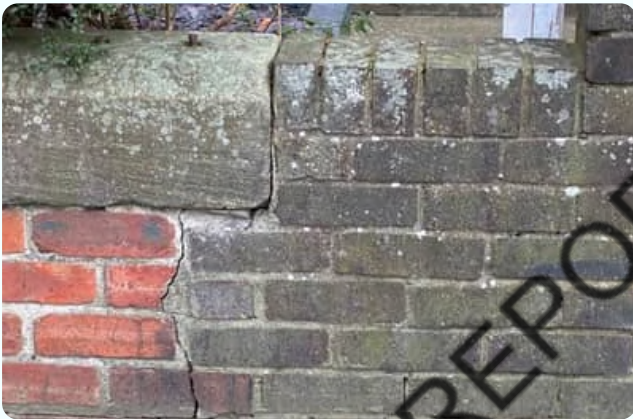
Significant moss and lichen growth on the brick wall surfaces, particularly on the coping stones and upper bricks. This biological growth is visible as green and white patches.

Prolonged moisture retention on the brick surfaces, likely due to shading and poor drying conditions.

Moss and algae on brickwork

Clean affected areas using appropriate biocide treatments and soft brushing. Improve drainage and sunlight exposure if possible to reduce moisture retention.

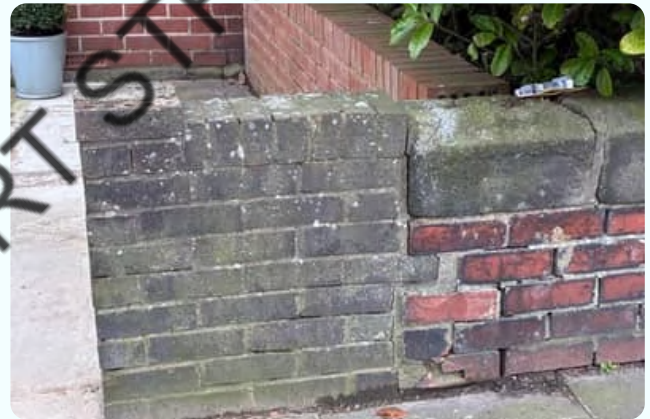
Visible spalling and loss of brick faces and mortar joints, particularly at the base of the wall and corners. Some bricks show holes and surface erosion.

Weathering, moisture ingress, and freeze-thaw cycles causing brick and mortar degradation.

Damaged bricks and mortar loss

Replace severely damaged bricks and repoint mortar joints using compatible materials. Inspect for underlying causes of moisture ingress.

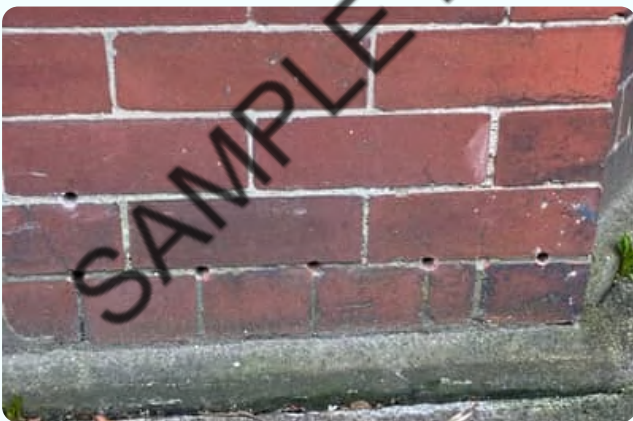
Damaged bricks and mortar loss

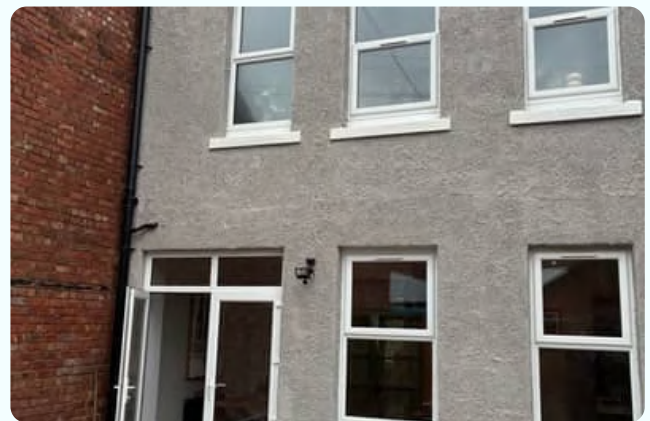
The external render on the rear facade appears intact with no visible cracks, delamination, or staining. Window and door surrounds are well maintained.

Render in good condition

Continue regular maintenance and inspections to ensure render remains sound.

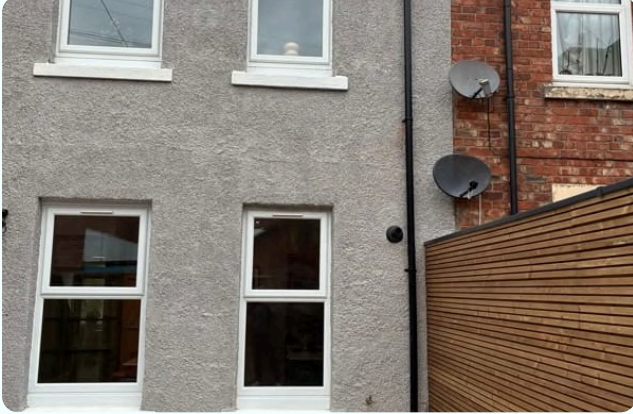
Render in good condition

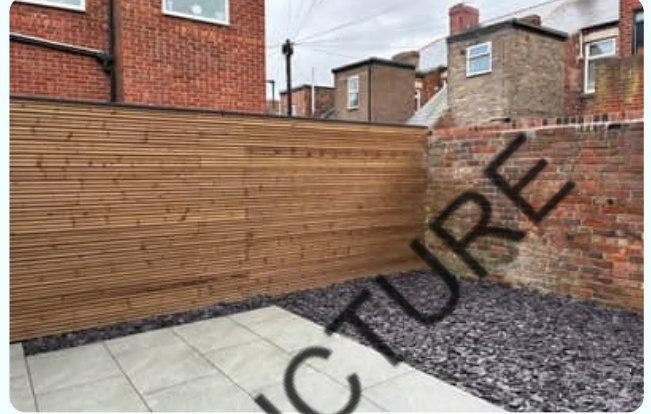
Modern wooden fencing and paved patio areas are in good condition with no visible damage or deterioration.

Fencing and paving well maintained

Routine maintenance to preserve condition.

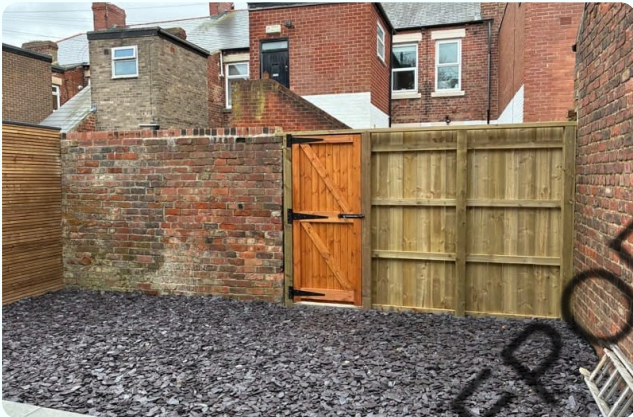
Fencing and paving well maintained

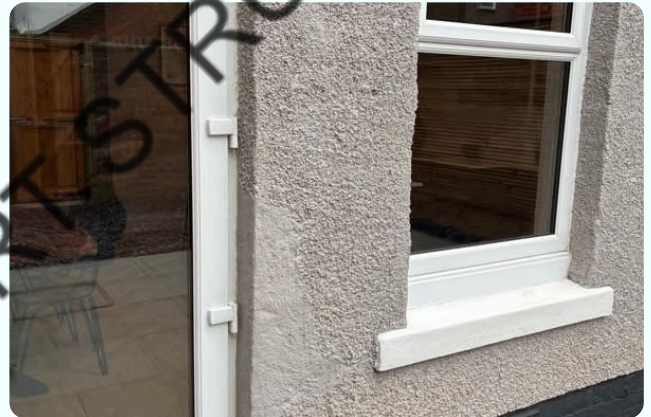
Render in good condition

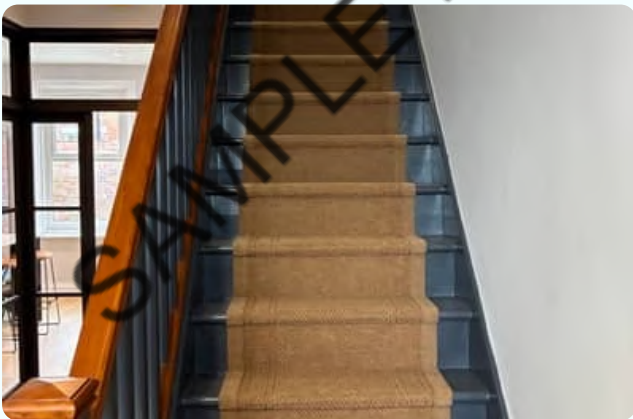
The painted stair stringers on either side of the carpet runner exhibit scuff marks and minor surface wear, reducing the finish quality.

Contact damage from foot traffic and objects, normal wear over time.

Scuffed paint on stair stringers

Repainting or touch-up of the stair stringers to maintain protection and appearance is advised.

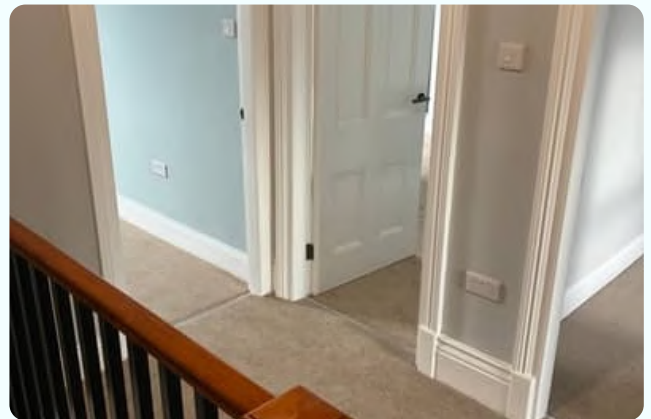
Walls and door frames in the hallway show no visible cracks, stains, or damage, indicating satisfactory condition.

Walls and door frames in good condition

Maintain regular decoration and inspection.

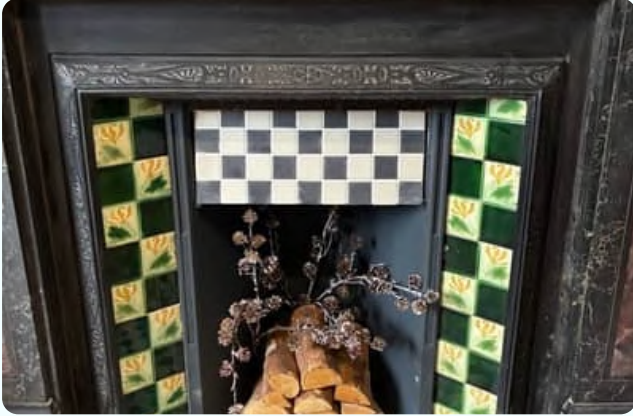
There is visible minor chipping to some of the decorative tiles on the fireplace surround, particularly on the green and yellow floral tiles. The damage is localized and does not appear to affect the structural integrity of the fireplace.

Wear and tear from use or accidental impact over time.

Chipped tile on fireplace surround

Careful replacement or repair of the damaged tiles by a specialist tiler or restoration expert to match the existing decorative pattern.

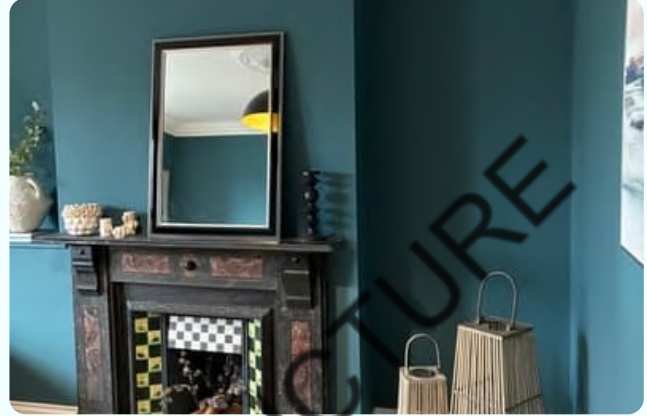
Chipped tile on fireplace surround

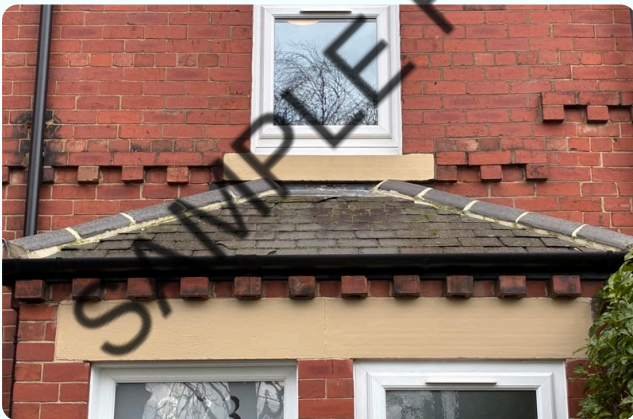
Visible moss and algae growth is present on the roof tiles, particularly on the lower slopes and near the ridge tiles. This biological growth can retain moisture and may accelerate tile deterioration.

The presence of moss and algae is likely due to prolonged moisture retention on shaded or less exposed areas of the roof, combined with organic debris accumulation.

Moss and algae on roof tiles

Recommend cleaning the roof tiles using appropriate biocide treatments to remove moss and algae. Regular maintenance to prevent regrowth is advised.

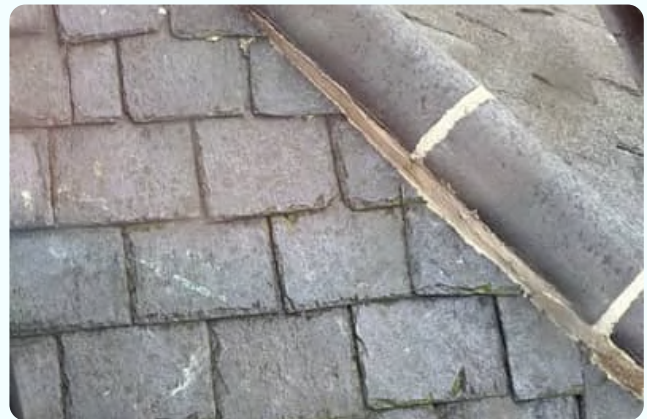
Moss and algae on roof tiles

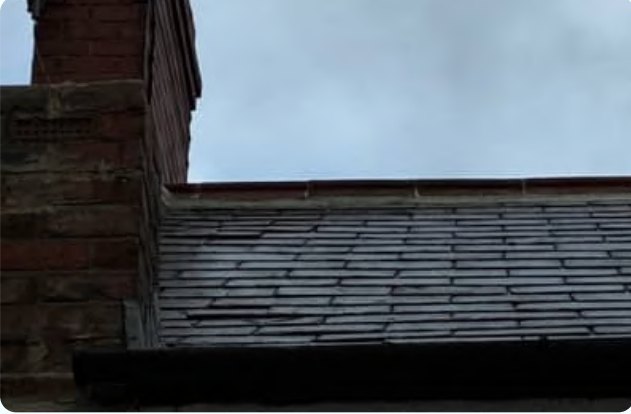
The lead or metal flashing around the chimney appears aged and may have minor gaps or deterioration, risking water ingress.

Weather exposure and thermal movement cause flashing to degrade over time.

Flashing around chimney shows wear

Recommend inspection by a roofing specialist and repair or replacement of flashing as necessary to ensure watertightness.

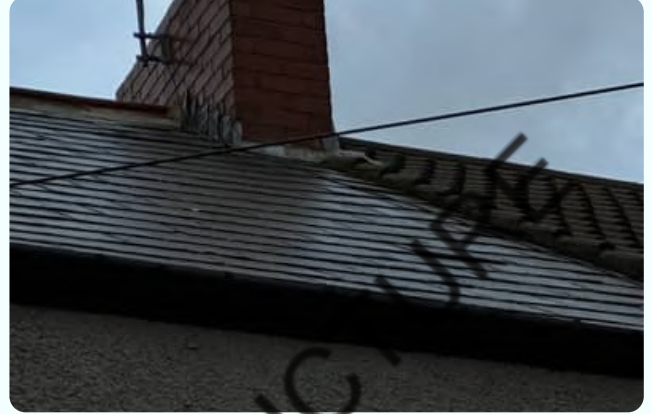
Flashing around chimney shows wear

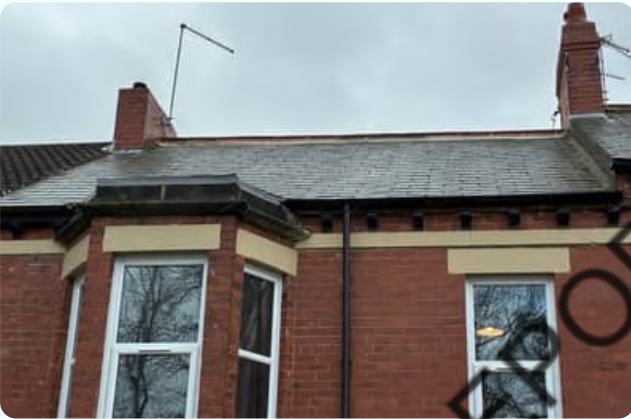
Moss and algae on roof tiles

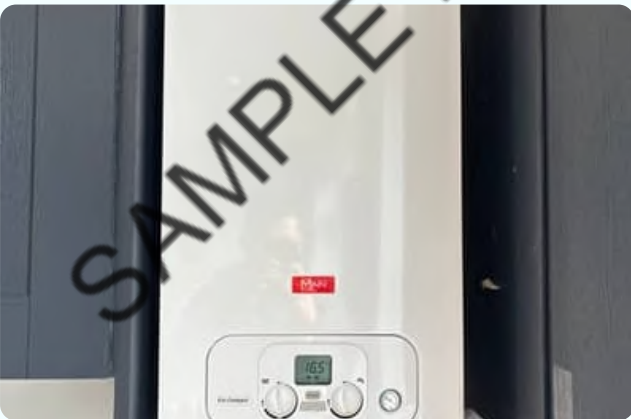
The boiler is installed within a cabinet with apparent adequate clearance around the unit for ventilation and servicing. No visible signs of damage, leaks, or poor installation are evident.

Boiler installed within cabinet

Regular servicing and inspection recommended to ensure ongoing safe operation.

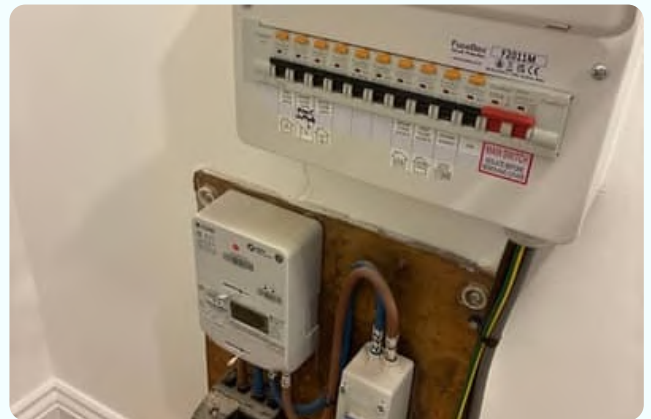
The electrical panel and associated meters are mounted on a timber board fixed to the wall. The timber appears aged and may not provide optimal fire resistance or secure mounting for electrical components.

Use of timber board as a mounting surface, possibly for ease of installation or retrofit purposes.

Electrical panel mounted on timber board

Recommend assessment by a qualified electrician to consider replacing the timber board with a fire-resistant mounting panel and ensure compliance with current electrical safety standards.

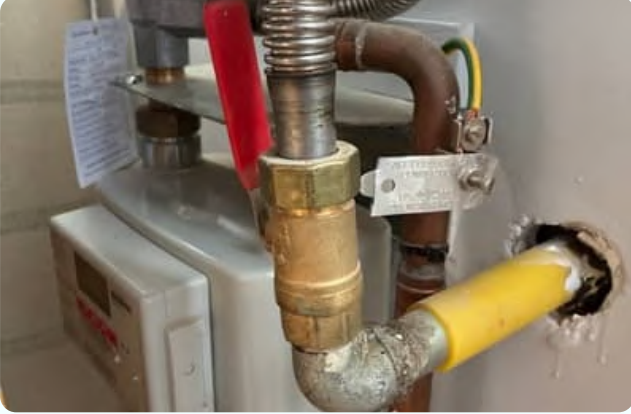
Visible corrosion and surface deterioration are present on the metal gas pipe and fittings, particularly at the elbow joint and near the connection points. This indicates potential long-term exposure to moisture or chemical agents.

Corrosion likely caused by condensation or minor leaks around pipe joints and fittings over time.

Corrosion visible on gas pipe

Recommend a qualified gas engineer to inspect the pipework for integrity and replace or treat corroded sections. Protective coatings or insulation may be applied to prevent recurrence.
